NATIONAL BUREAU OF STANDARDS REPORT

NBS PROJECT		NBS REPORT
1002-30-10627	March 12, 1962	7456

FIRE ENDURANCE TEST

TWO BULKHEAD ASSEMBLIES

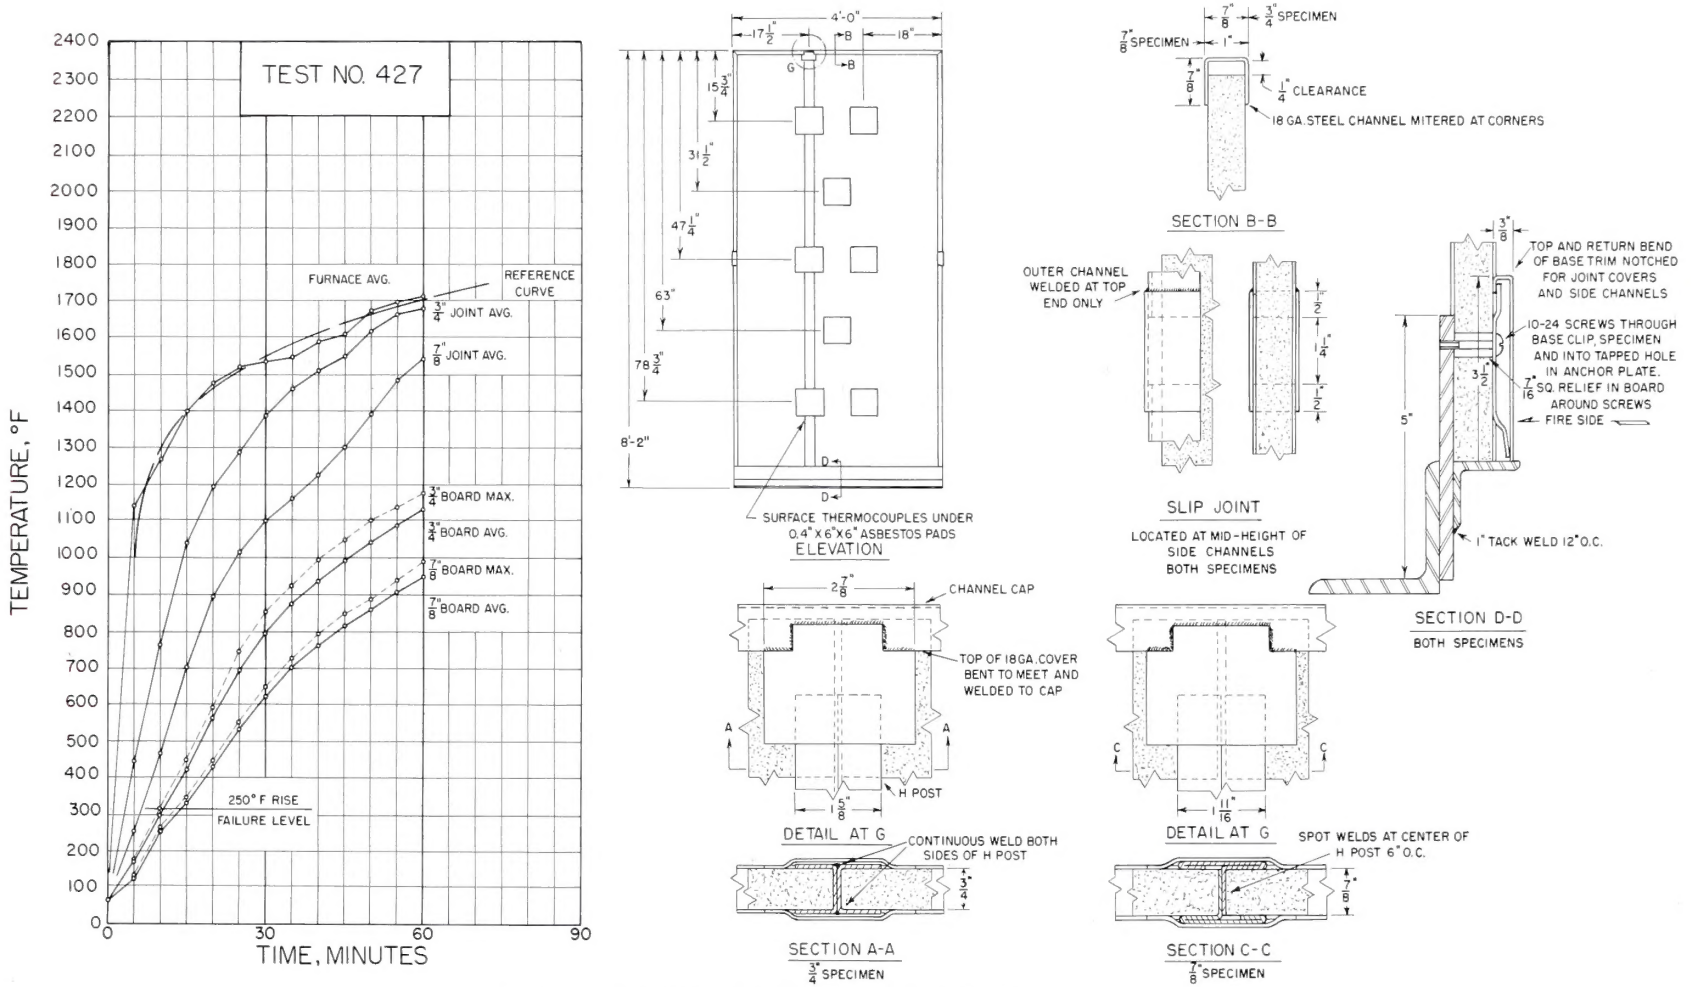
FIG. 1 – TEMPERATURE DATA AND CONSTRUCTION DETAILS

Both specimens continued as satisfactory barriers to flame passage throughout the 1-hr test, there having been only two hairline cracks in the 7/8-in. thick specimen and none in the 3/4-in. thick specimen. The limiting temperature rise of 250°F, at any thermocouple on the unexposed surface of the marine board, was reached at 10.2 minutes for the 3/4-in. board and at 13.7 minutes for the 7/8-in. board. The fire exposure severity was 100.2 percent. Additional temperature data are represented in Figure 1.

The results of the test indicated that each of the particular specimens tested was a satisfactory flame barrier for one hour, but that the limiting temperature rise was reached at 10.2 min for the 3/4-in. board and at 13.2 min for the 7/8-in. board.
